EAST BAY CLOSE, CARDIFF

**PRELIMINARY BAT ROOST
ASSESSMENT**

Report No: RT-MME-124930-02

Date: March 2017
Date Revised: April 2017

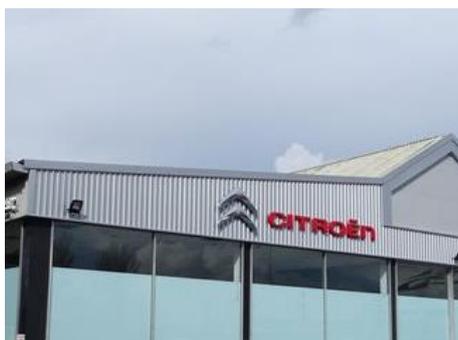
A former car showroom and garage was located in the centre of the site. This was a large, single-storey building with a pitched, corrugated metal roof and raised ridge section (Plate 4.1). The lower half of the walls was constructed of brick whilst the upper half was constructed of corrugated metal sheets. No cracks or crevices were present in the brickwork and the metal sheets were tightly fitted. The southern elevation comprised a large glass frontage with windows set in tightly fitted metal frames. The metal soffits were predominantly tightly fitted and the roof was well-sealed. A gap was noted in the south-eastern corner of the soffit where two panels were not tightly sealed. However, this was filled with insulation making it unsuitable as an access point or roosting feature for bats. No potential ingress points or roosting opportunities for bats were identified. No evidence of bats was recorded.

Plate 4.1: Former car showroom and garage

The buildings on site were fully inspected and no bat roosts were identified. These buildings had no potential for roosting bats. The survey data obtained for the site is valid for 12 months from the survey date. If development works to the surveyed buildings have not commenced within this timeframe it will be essential to update the survey effort to establish if suitable features have developed and if bats have colonised the buildings in the interim. In the unlikely event that a bat is found during demolition works all works must immediately cease and a suitably qualified ecologist should be contacted.

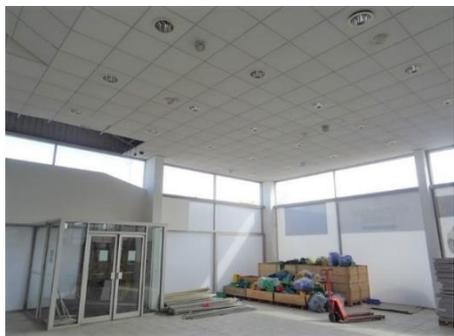
Internally, the building was divided into two sections; the former showroom and the garage. The former showroom occupied the southern half of the building and was vacant at the time of the survey (Plate 4.2). Conditions within this area were very light due to the large glass frontage, reducing its suitability for bats. Wooden boards were visible at the gable end where one of the internal panels was missing but no potential roosting features were identified (Plate 4.3). The former showroom had a false ceiling which was damaged in places revealing the roof structure above (Plate 4.4). The exposed corrugated metal roof and steel beams offer negligible roosting potential for bats.

Plate 4.2: Interior of former showroom

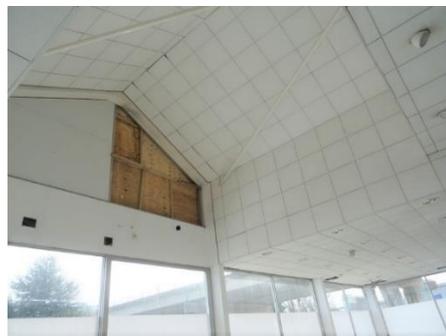
Plate 4.3: Wooden board visible at gable end

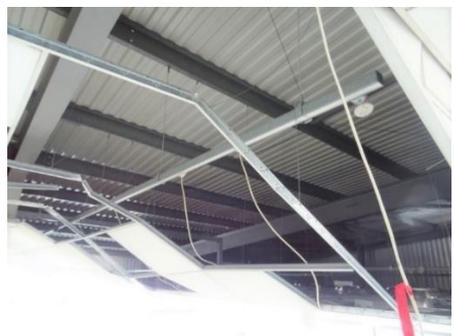
Plate 4.4: Roof structure visible through area of damaged ceiling

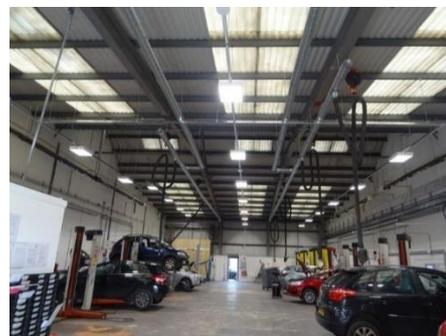
The garage occupied the northern half of the building and was in use at the time of the survey (Plate 4.5). Conditions within this area were very light due to the presence of skylights, reducing its suitability for bats. The garage was open plan revealing the same roof structure that was visible in the former showroom. No features suitable for use by bats were identified during the internal assessment and no evidence of bats was recorded.

Plate 4.5: Garage area still in use

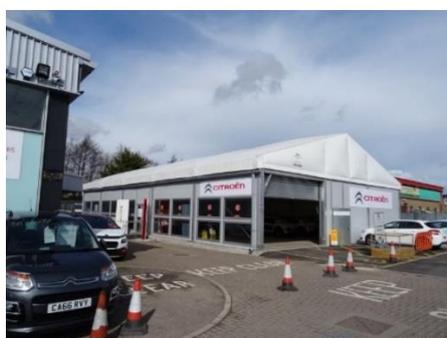
A temporary car showroom was present in the eastern part of the site. This was a single-storey, steel-framed building of prefabricated construction with a pitched, plastic roof (Plate 4.6). The western elevation comprised a large glass frontage with windows set in tightly fitted metal frames. The building was in good condition with no potential ingress points or roosting opportunities for bats. No evidence of bats was recorded.

Plate 4.6: Temporary Car Showroom

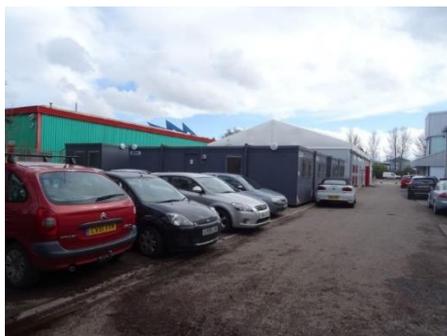
A group of six portacabins was present in the north-eastern part of the site (Plate 4.7). These were being used as sales offices and public toilets at the time of the survey. They were in good condition with no potential ingress points or roosting opportunities for bats. No evidence of bats was recorded.

Plate 4.7: Portacabins

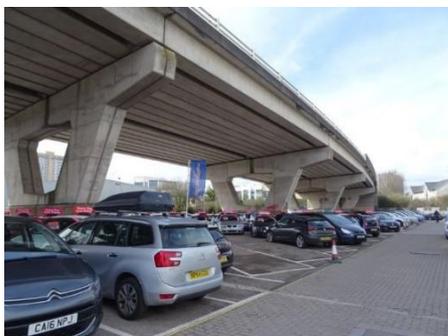
The A4234 flyover passes over the western part of the survey area (Plate 4.8). This was a large concrete structure with concrete supports. Expansion gaps were present between the concrete panels, offering potential roosting features for bats (Plate 4.9). These features could not be fully inspected; however, it is understood that the structure will not be impacted by the proposed works.

Plate 4.8: A4234 flyover

Any lighting installed under the flyover should be low level and directional to ensure no additional increases in light levels of the structure. It is recommended that once developed the lighting strategy for the site should be approved by a suitably qualified ecologist. If increased illumination of the flyover cannot be avoided further bat surveys will be required to determine presence/absence of bats within the structure and identify appropriate mitigation measures where appropriate.

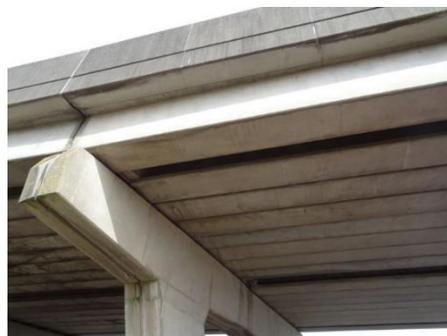
Plate 4.9: Expansion gaps between concrete panels

The A4234 flyover had expansion gaps between the concrete panels, offering potential roosting locations for bats. Therefore, the structure was considered to have high potential to support roosting bats. These features could not be fully inspected; however, it is understood that the structure will not be directly impacted by the proposed works.

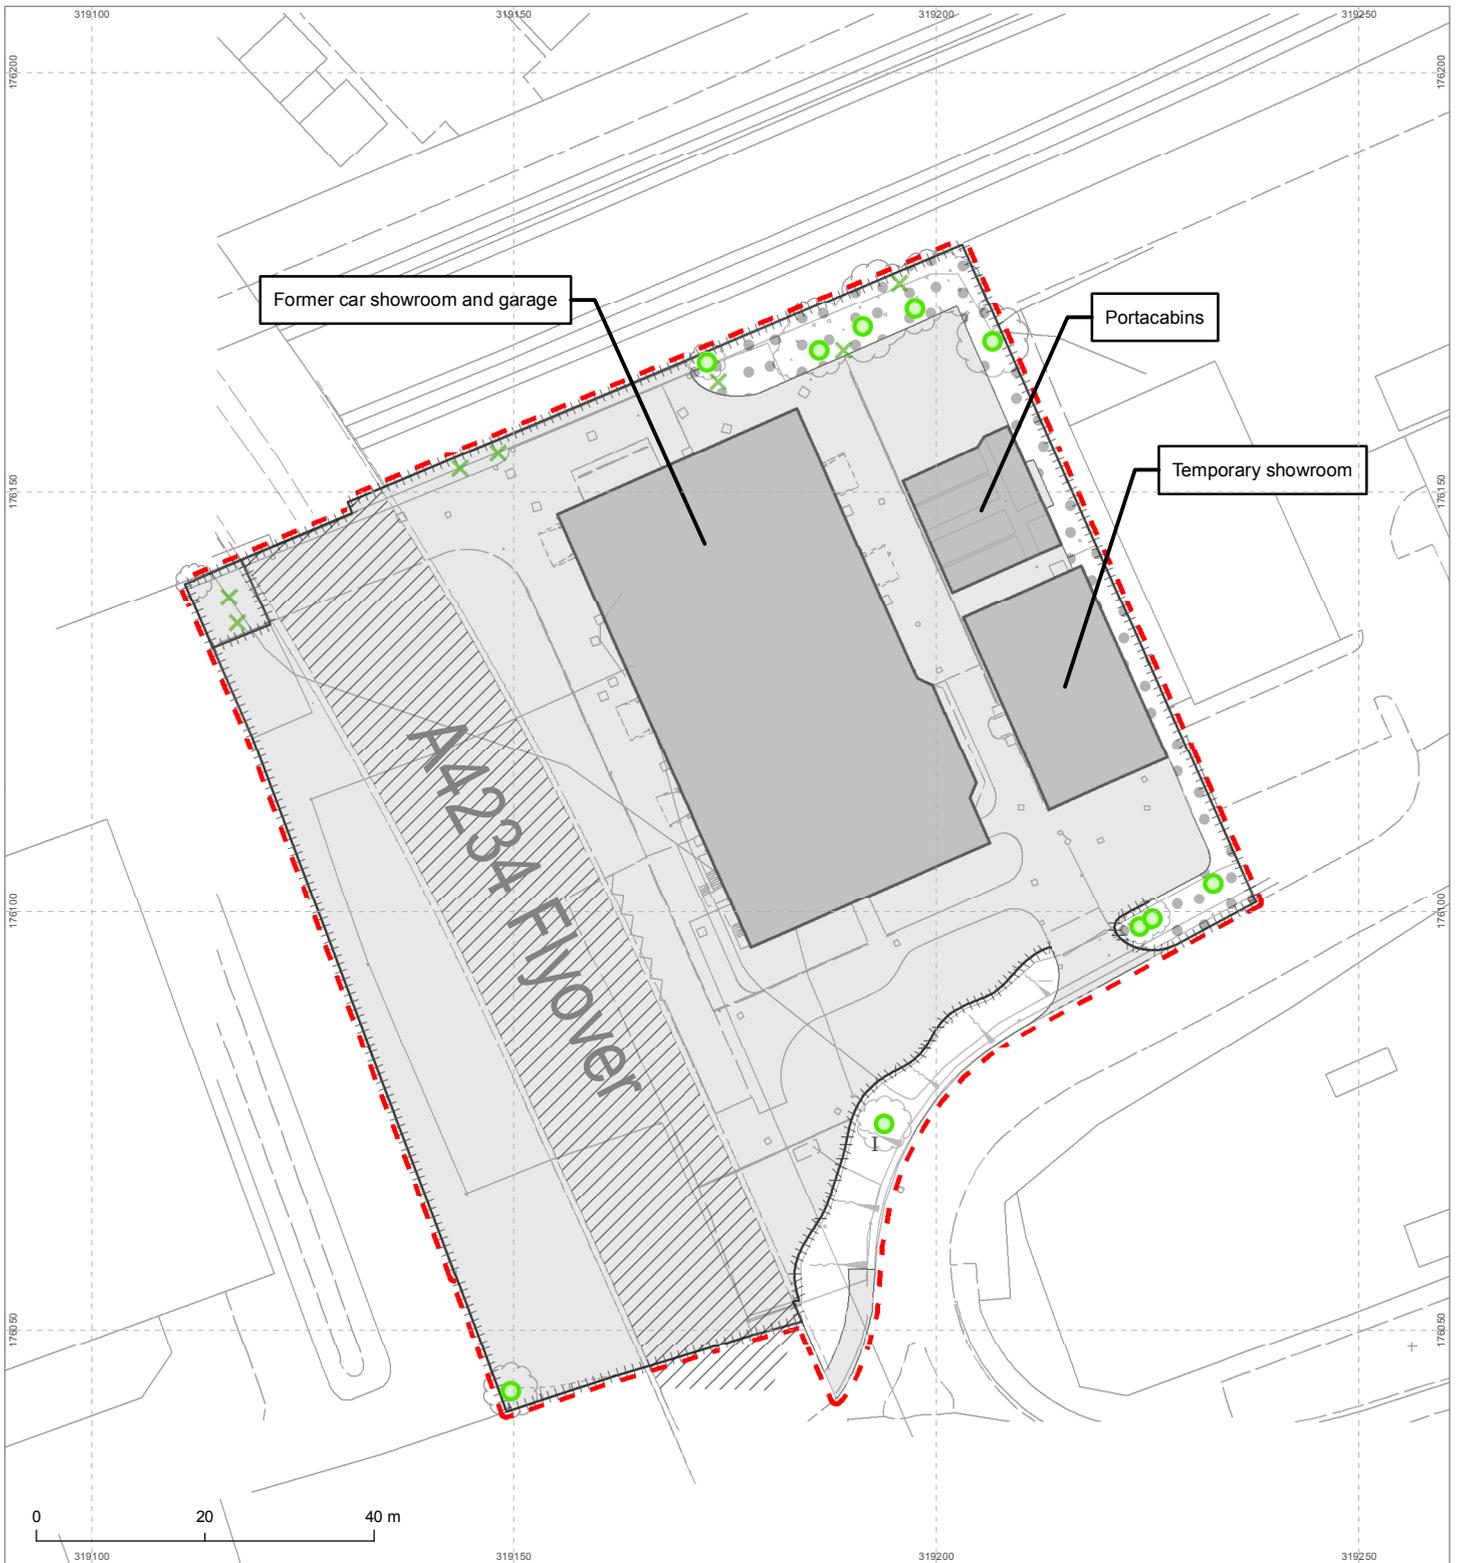
Drawing C124930-02-01 – Preliminary Bat Roost Assessment

The Preliminary Bat Roost Assessment was conducted on 21st March 2017 by Sophie Meredith (Senior Ecological Consultant). Drawing C124930-02-01, illustrating the layout of the buildings on site and the results of the survey is provided in Chapter 7.
